SITE: McKINLEY Elementary School
PRIN: Ms. Bonnie Coffey-Smith
ADDRESS: 1025-14th Street
S.F., CA 94114
PHONE: (415) 241-6300
CDS CODE: 38 68478 6041424

McKINLEY ELEMENTARY SCHOOL
3-YEAR REINSPECTION AND UPDATE OF EXECUTIVE SUMMARY

School Site: McKinley Elementary School
1025 - 14th Street
San Francisco, CA

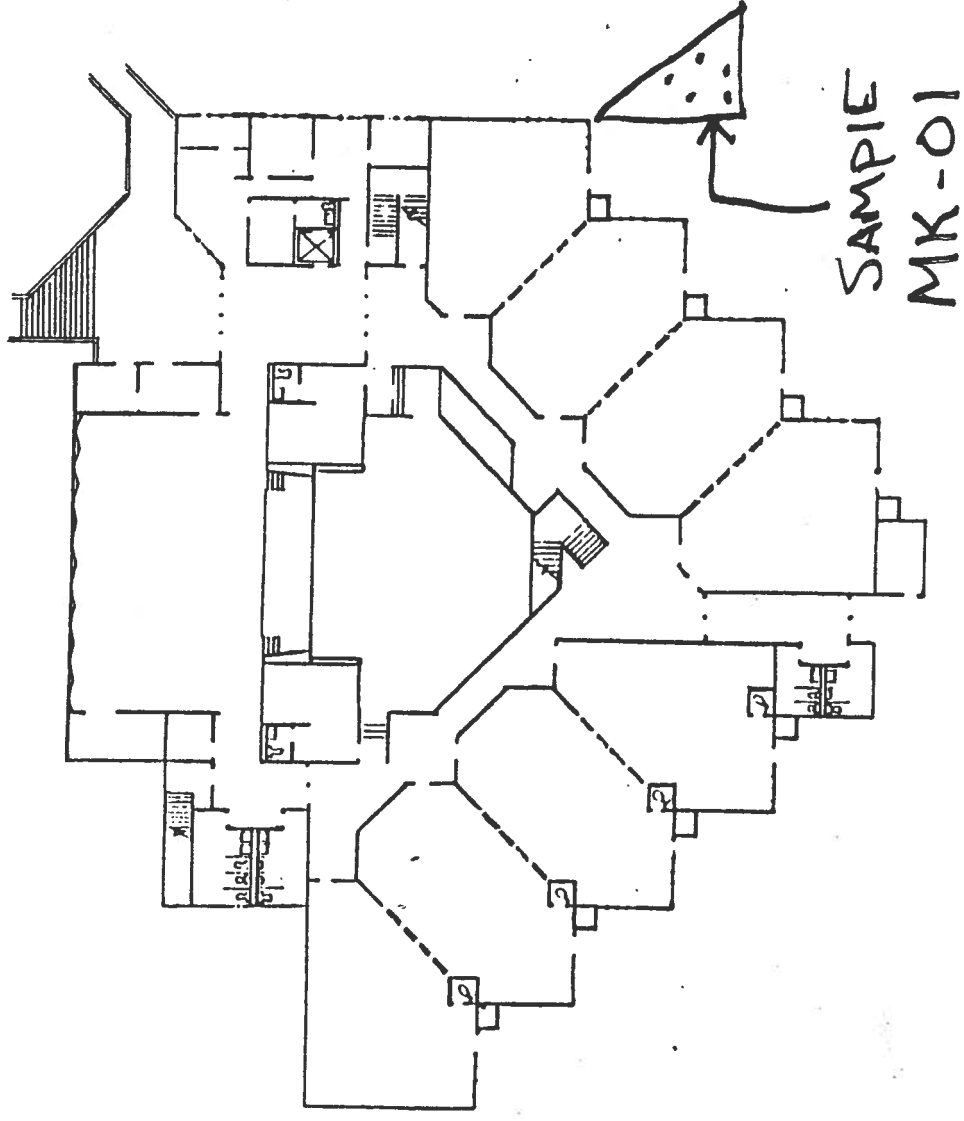
McKINLEY ELEMENTARY SCHOOL
FIRST FLOOR PLAN

One soil sample was collected from the play area outside Room 12. The sample location is depicted on the Site Diagram contained in Appendix B. Results of the composite soil sample indicated the presence of Lead at 32 mg/kg (ppm), which is below the US Department of Housing and Urban Development standard of 400 mg/kg for bare soil in play areas. A copy of the laboratory report is contained in Appendix C.
